Manhole Inspection Summary

Manhole # S13UU_025MH

Insp Date: **7/11/08 9:59 AM**

Location Address: **LIBERTY HEIGHTS AVE**

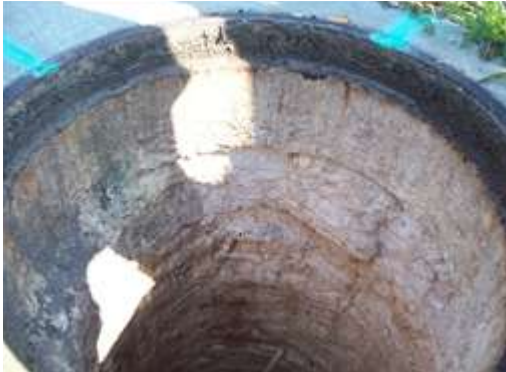
Defect 2

Condition: ☐ Sound ☒ **Cracked** ☐ Root Intrusion ☒ **Loose Brick** ☐ Deteriorated

Infiltration: ☐ None ☐ Joint ☒ **Cracks** ☐ Mortar ☐ Roots ☒ **Wall**

CRACKS AND LOOSE BRICKS OF BARREL

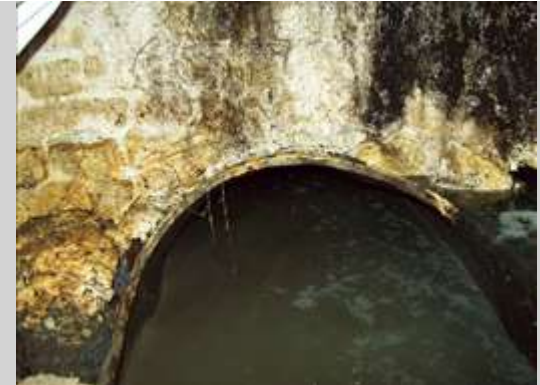
12 O'Clock Outflow

24 in. Circular Gravity Sewer
Pipe Out @ 12 O'Clock

Pipe Height: (in.) Direct
Pipe Material: **PVC** ☐ Pipe Lined
Invert Depth: **35.73** (ft.) Flow Characteristics: **Fast**
Deposits: ☒ None ☐ Mud ☐ Sludge ☐ Debris ☐ Grease
Silt Depth: (in.) Deposits Extent:
Infiltration: **None** Pipe Seal Cond: **Sound**

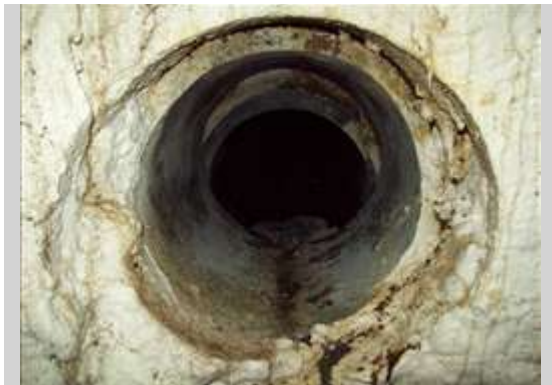
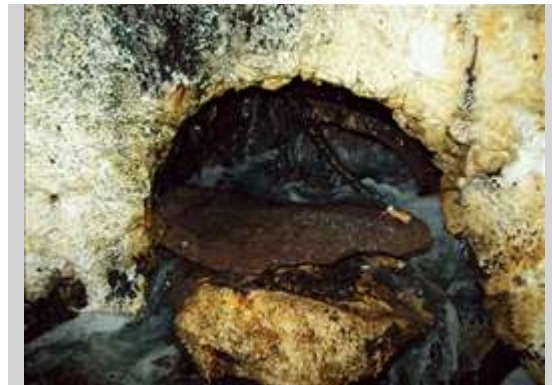
3 O'Clock Inflow

15 in. Circular Gravity Sewer
Pipe In @ 3 O'Clock

Drop In @ 3 O'Clock

Pipe Height: (in.) Direct
Pipe Material: **Clay** ☐ Pipe Lined
Invert Depth: **21.85** (ft.) Flow Characteristics: **Fast**
Deposits: ☐ None ☐ Mud ☐ Sludge ☒ **Debris** ☐ Grease
Silt Depth: **10** (in.) Deposits Extent: **Heavy**
Infiltration: **Evidence** Pipe Seal Cond: **Broken**

Drop: **Outside Direct**
Angled: Reading: (ft.)
Inv Depth: **34.46** (ft.)

Drop Condition: **Open**

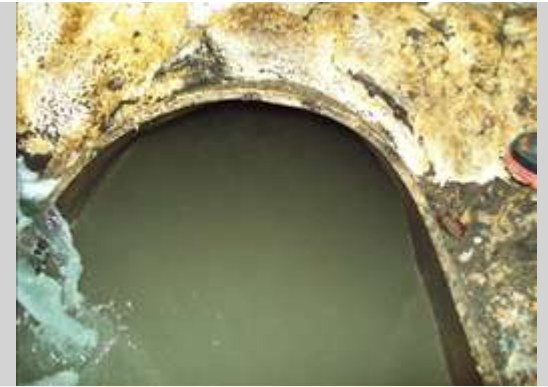
6 O'Clock Inflow

24 in. Circular Gravity Sewer
Pipe In @ 6 O'Clock

Pipe Height: (in.) Direct

Pipe Material: **PVC** ☐ Pipe Lined

Invert Depth: **30.80** (ft.) Flow Characteristics: **Fast**

Deposits: ☒ None ☐ Mud ☐ Sludge ☐ Debris ☐ Grease

Infiltration: **None** Pipe Seal Cond: **Unknown**
